# Remediation Strategies and Water Quality of Estuarine Impoundments

Jens Lamping

A thesis submitted in partial fulfilment of the requirements of the Council of the University  
of Durham for the Degree of Doctor of Philosophy (PhD)

### **Remediation Strategies and Water Quality of Estuarine Impoundments**

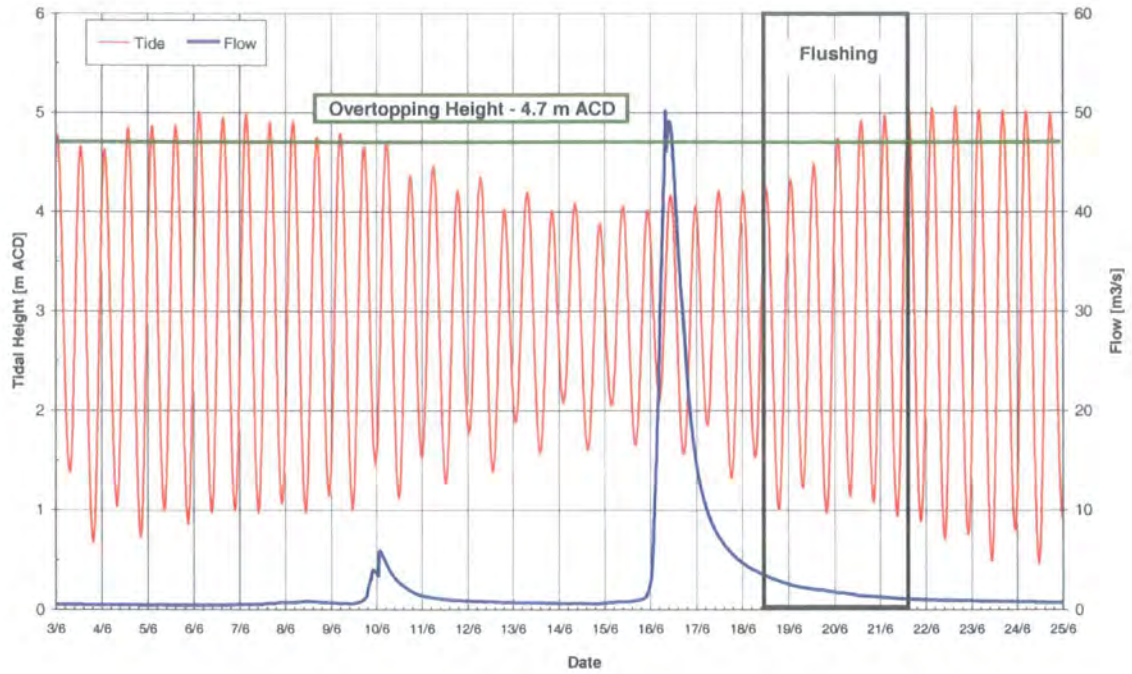
River discharges of the River Wansbeck are recorded by the EA Gauging Station at Mitford (NZ 175 858) 150 m downstream of the confluence with the River Font. Records for the survey period were available as 15 min. readings in  $\text{m}^3/\text{s}$  and represented summer baseflow conditions, with a major spate occurring around midday of 16/06/01 (Figure 4-9).

Figure 4-9 River flow and tidal regime during flushing survey

The tidal regime for the Wansbeck estuary is recorded at the Sea Level Gauging Station North Shields (NZ 359 682), which is operated by the UK Hydrographic Office. Quality controlled 15 min. level observations of this station were obtained from the British Oceanographic Data Centre (BODC) and plotted against the flow records (Figure 4-9). The time and height differences for HW and LW applicable for the closest secondary port at the mouth of the River Blyth are negligible ( $< 10$  min., 0.00 m HW, UK Hydrographic Office, 2001) within the measured time frame of the survey period, so that the observed levels from North Shields were directly applied in this section. The barrage height of 4.74 m ACD is also indicated (Figure 4-9) to illustrate overtopping and non-overtopping conditions in the impoundment.

- Tides OT: Describes the tidal regime in number of tides overtopping the barrage, as defined by the observed tide levels relative to the construction levels (Figure 4-9). Negative values stand for non-overtopping and positive values for overtopping tides.

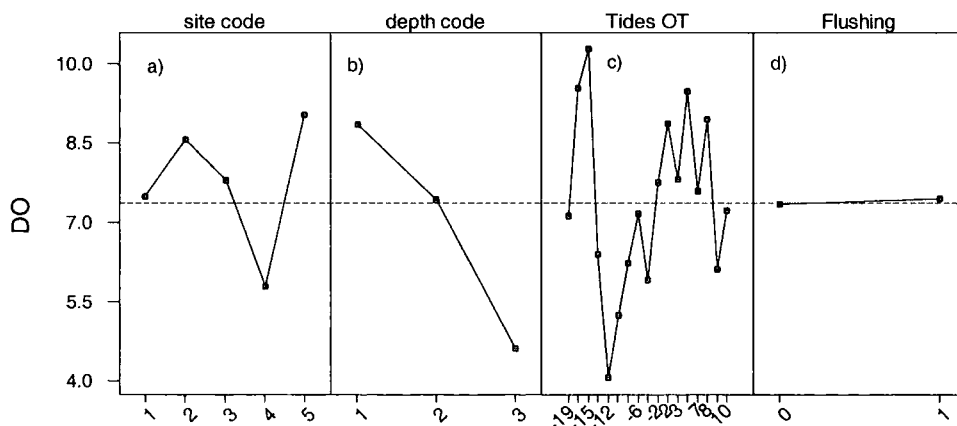
**Figure 4-10 Main effects plot for DO means [mg/l] during flushing survey on the River Wansbeck, dotted line indicates overall mean**

The two shallow sites (Figure 4-10-a) 2 and 5 of the impoundment indicate higher DO means than the remaining sites. Site number 4 showed by far the lowest DO conditions due to its distance and depth. The depth code (Figure 4-10-b) indicates an almost linear decrease in DO with increasing depth. Mean DO conditions at depth were below the 5 mg/l standard, which is commonly applied to salmonid rivers. The change of the tidal regime (Tides OT) to non-overtopping conditions introduces a general decrease in DO levels within the impoundment. Inconsistencies towards the end of each tidal period can be explained by the relatively large influence of the river spate flushing the system during the monitoring. In contrast, the external factor of flushing via lock operation (Figure 4-10-d) had no effect on the DO means of the whole impoundment.

The tidal regime (Tides OT) produced by far the largest effect among the included factors explaining 13.7 % of DO variation during the survey period. The influence of distance (Site Code) and depth (Depth Code) on the measured DO variation is of similar size with 4.6 % and 5.1 % respectively. The flushing showed no significant impact on DO levels during the survey period ( $\omega^2=0.00$ ). The variance for each factor level is illustrated in the main effects plot (Figure 4-10).

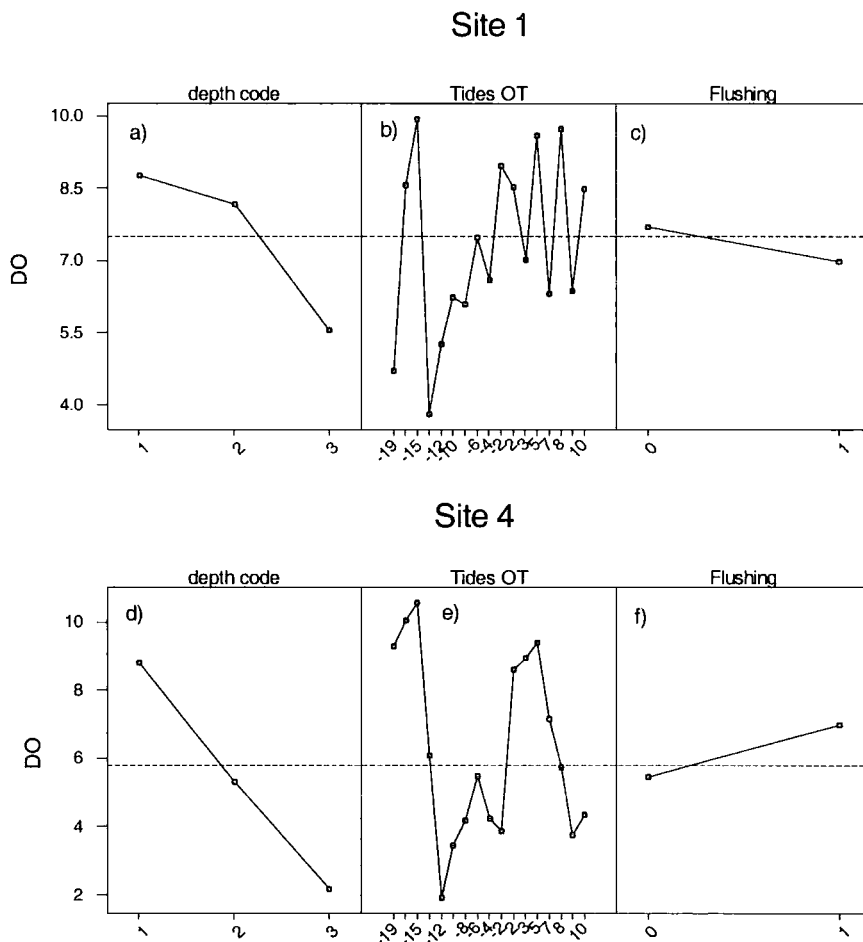
**Figure 4-11 Main effects plot for DO means [mg/l] at the Barrage (Site 1) and Caravan Park (Site 4) during flushing survey on the Wansbeck, dotted line indicates overall mean**

The upstream site at Caravan Park (Depth 4.88 m) shows a considerably larger influence of depth on the DO means (Figure 4-11-a, d) than the barrage site (Depth 3.66 m). Whereas surface conditions are similar, the mean DO level linearly drops to values <3 mg/l at depth for CP compared to deep layer means of 5.5 mg/l at the barrage. As expected, the impact of the tidal regime is easier to follow at the barrage (Figure 4-11-b), where DO conditions during overtopping are higher when compared to the Caravan Park site where DO levels quickly decrease towards the end of the overtopping cycle. The effect of external flushing is very low at both sites especially when compared to the possible mixing initiated by the river spate. The barrage site even indicates lower DO values during and after flushing was initiated.

Since the shallow sites showed higher DO means, indicating smaller likelihood for stratification, it was decided to examine the main effects at the deep sites separately. The Barrage site (1) and the Caravan Park site (4) were chosen to represent the distance range in which deep sites occur within the impoundment and which are in reach of tidal influx (Figure 4-11).

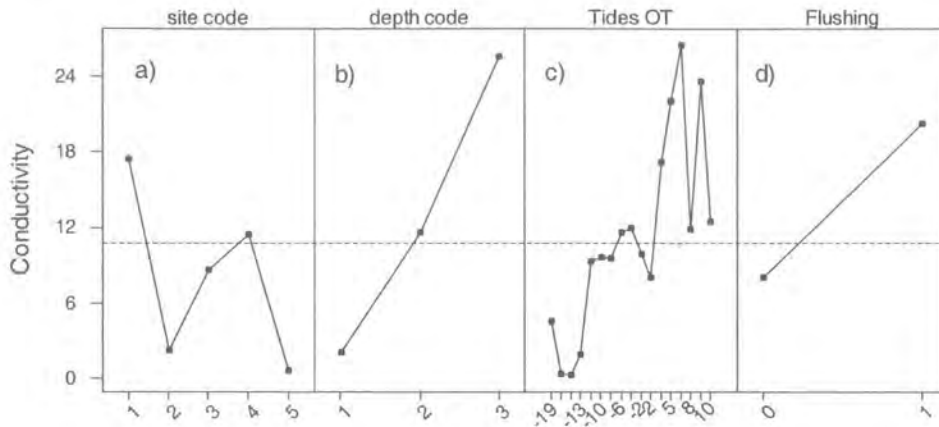
**Figure 4-12 Main effects plot for conductivity means [mS/cm] during flushing survey on the Wansbeck, dotted line indicates overall mean**

The saline water with high conductivity values accumulates mainly at the deep sites within the impoundment (Figure 4-12-a). The barrage site showed the highest conductivity mean of about 18 mS/cm. The overall mean is comparably high indicating large accumulation of seawater during overtopping. The stratified conditions are well represented by an almost linear transition from surface freshwater (Figure 4-12-b) to saline deep waters of very high conductivities (depth code 3 > 24 mS/cm). As expected, the change of conductivity levels follows the tidal regime with high levels during OT and decreasing values during Non-OT. However, during 8 and 12 Non-OT tides, the mean level for conductivity remained stagnant and then suddenly plunged into lower values. Flushing shows a positive response with increasing conductivity levels during opening of the lock gates (Figure 4-12-d).

the error term is very high ( $\omega^2=79.9\%$ ), which indicates that the model is far from complete. However, the main effects plot of the included factors (Figure 4-12) helps in understanding the principle dynamics in this estuary. No significant interaction of factors was found during modelling.

For the Wansbeck, the density pools were identified by the accumulation of high conductivity waters at the deeper upstream sites Caravan Park and Railway Bridge (Figure 4-12-a). Currents introduced at the barrage through the discharge of water were unable to overcome the morphological barriers due to restriction of vertical movement within stratified estuaries (Figure 4-1). Thus, withdrawal of saline waters can be achieved in the vicinity of the inlet (navigation lock) but will not affect pooled waters beyond the first major upstream bed elevation where they are trapped by a falling halocline. This was one of the major findings during Tawe flushing survey, which in the following years of operational sluicing (1994-1997) proved to be the main difficulty to overcome and eventually led to the implementation of the aerator scheme.

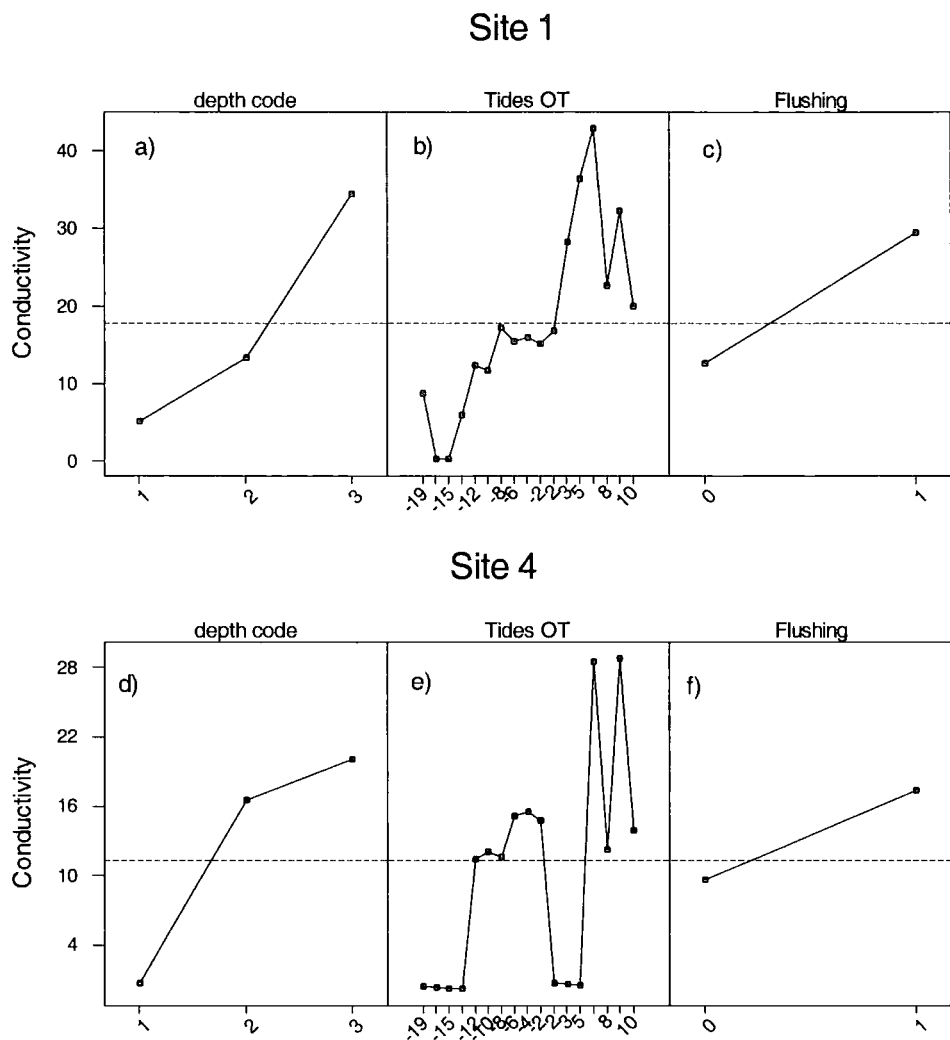
**Figure 4-13 Main effects plot for conductivity means [mS/cm] at the Barrage (Site 1) and Caravan Park (Site 4) during flushing survey on the Wansbeck, dotted line indicates overall mean**

At the CP site the influence of depth on conductivity is larger between surface and mid depth layer in comparison to the Barrage site. Conductivity means at CP change from freshwater levels at the surface to 16 mS/cm for the mid layer and continue to increase only slightly to approximately 20 mS/cm for the deep layer. In contrast, levels continue to increase between mid and deep layer to means of 35 mS/cm at depth for the barrage site. The tidal regime is again well reflected by the conductivity means at the barrage showing increasing levels with more overtopping, while stagnancy and dilution is occurring during Non-OT. Both sites indicate higher means during and after the flushing operation with barrage levels rising from 10 to 30 mS/cm.

Since the deeper sites showed higher conductivity means as result of accumulation of denser seawater, it was decided to examine the main effects at these sites separately. Again, the Barrage site (1) and the CP site (4) were chosen to represent the distance range in which deep sites occur within the impoundment that are in reach of tidal influence (Figure 4-13).

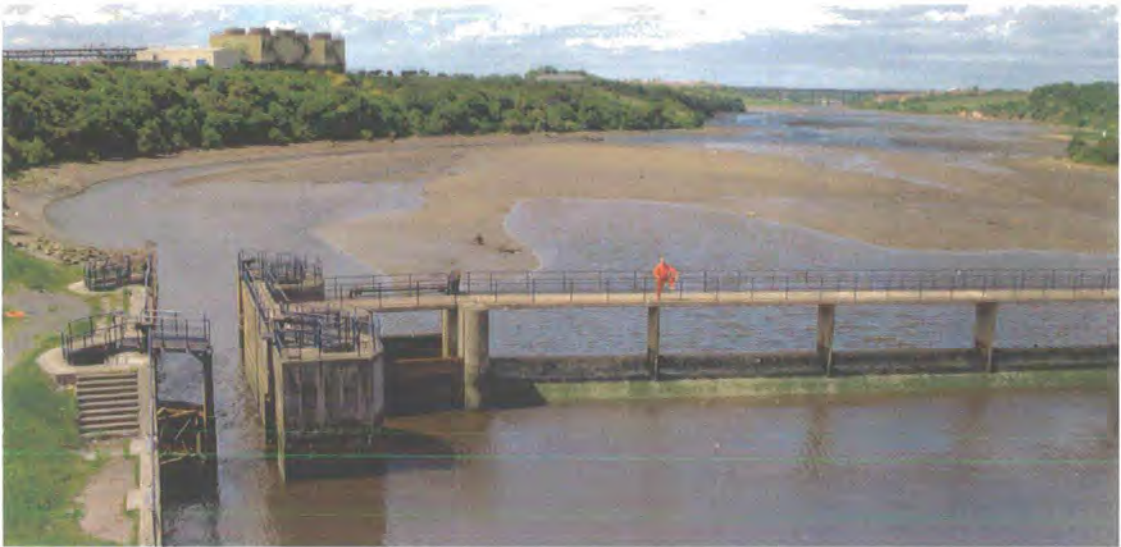
**Figure 4-14 Image of the Wansbeck impoundment during flushing, looking upstream**

The remaining baseflow ran as a narrow stream utilizing the main channel bed. Falling surface levels lead to the pooling of water in the deeper hollows upstream reducing the chances here for water exchange via tidal intrusion of fresh seawater. The only chance for survival of the aquatic communities, assembling in these quickly degrading pools, is a flush out via a river spate. Therefore, a complete drainage of the impoundment should be avoided during flushing operation if the bathymetry indicates the likelihood for stagnant water pools. For the Tawe impoundment a complete drainage can only be initiated by the EA in order to counteract worst case conditions of water quality. This also involves an intensive logistic operation in which the moored boats have to be removed from the marina in advance. The partial drainage option, as applied during the trial, has to ensure a required minimum residual flow of  $1 \text{ m}^3/\text{s}$  through the fishpass, which guarantees sufficient surface levels upstream and avoids pooling. However, these requirements further limit the withdrawal capacities at the barrage which reduces the overall efficiency of the sluicing technique.

An additional major problem associated with employment of flushing as a remedial measure is the lowering of the water level within the impoundment. Due to the elevated bed levels in the Wansbeck impoundment, the flushing operation quickly drained most of the former lake which exposed large areas of sediment to the atmosphere (Figure 4-14).

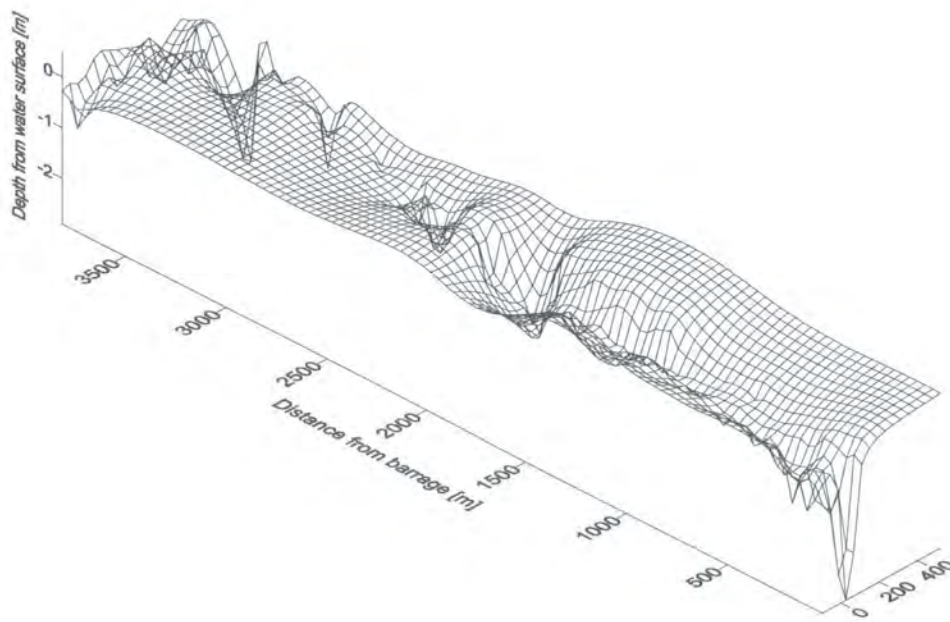
**Figure 4-15 Bathymetry grid of the Wansbeck impoundment from a survey in 1999**

The surveys suggest that a low level extraction via penstocks or sluices is advantageous over a gate solution discharging from the whole water column. The procedure utilizes the fact that vertical mixing is restricted under stratification and horizontal surge can create backwater currents within lower layers upstream. Under ideal bathymetric conditions, with a steady slope and no depressions in the river bed, the low level sluicing technique could be effective in managing water quality of an impoundment. However, the morphology of the introduced estuaries lead to hydrodynamic exclusion of further upstream reaches where denser water tends to pool in deep hollows of the river bed (Figure 4-15).

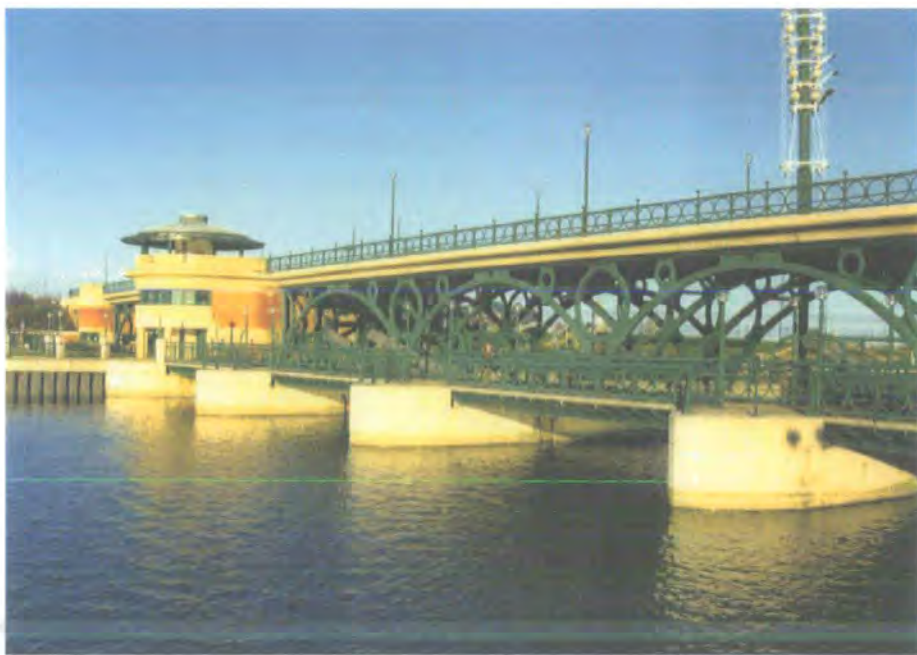
**Figure 5-2 Tees Barrage viewed from upstream**

Tees Barrage and Crossing Act in 1990. The site was not only chosen to bridge Stockton with Teeside Park (Middlesbrough) but also to exclude the heavily polluted tidal reaches of the lower estuary at this point and create an upstream freshwater river of improved water quality (Hall et al., 1995b). The Tees Barrage (Figure 5-2) became operational in December 1994 and incorporates four hinged, fish belly gates, a navigation lock (6 x 25 m), a fish/elver pass and a 450 m white water course as an additional recreational and flow control feature. The hydraulically variable fish belly gates maintain an upstream water level at MHWS height of 2.65 m AOD with a regulatory operating band between 2.35 m and 2.85 m AOD depending on river discharge and tide level. Due to the tidal exclusion design the 22 km freshwater lake created by the barrage is completely excluded from the pollutant receiving tidal water of the estuary, which was anticipated to improve the water quality upstream significantly (W.S. Atkins (Northern), 1989). Downstream an increase in saline stratification and a subsequent improvement of gravitational circulation supporting a better flushing of the polluted surface layers was predicted following two-dimensional modelling (HR Wallingford, 1989). Although, the barrage maintains a raised river level upstream it was designed to minimize the increase of river surface levels during flood conditions. Lowering of the gates within the bandwidth was predicted to increase levels up to 260 mm for a 1-in-100 year flood event with a progressive reduction to the former tidal limit at Low Moor Weir 42 km inland (Figure 5-1). However, major flood defence improvements have been undertaken since impoundment to protect the former flood struck urban areas of Yarm, Darlington on the River Skerne and Stokesley on the River Leven.

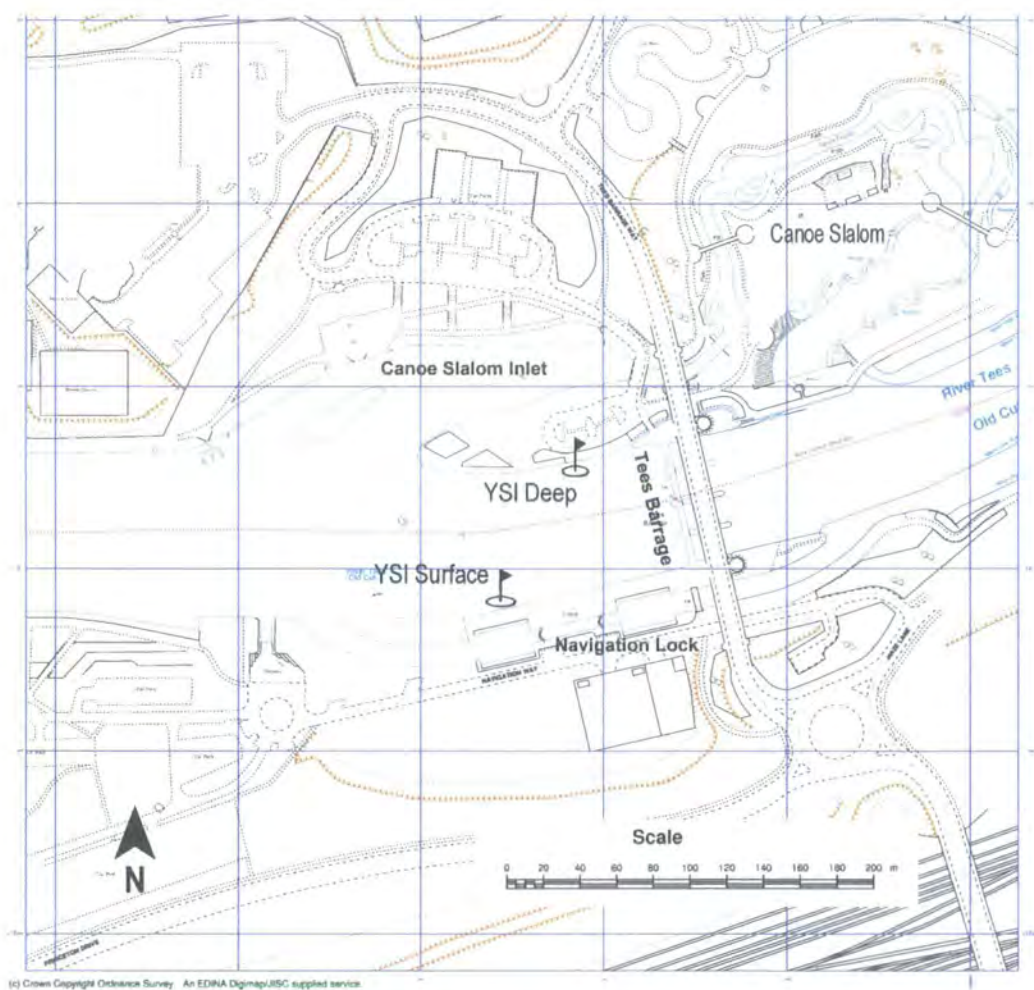
Figure 5-3 Water quality sonde locations in the Tees impoundment

In order to observe temporal water quality changes of the impoundment on a seasonal basis as well as during fluvial events a water quality sonde was installed which recorded parameters every 30 min. The sonde was fixed at a depth of 1 m under normal barrage operation (2.65 m AOD) in 100 m upstream distance from the gate crests on the southern bank of the impoundment (Figure 5-3 - YSI Surface).

An additional time series of the same major water quality parameters, but at 9 m depth, was made available from the EA Tees Region. The EA started continuous water quality monitoring in July 2002 also applying a YSI 6920 sonde fixed in a tube on the north bank of the impoundment (Figure 5-3). This probe also recorded at 30 min. intervals giving data directly comparable with that collected by the Durham University sonde.

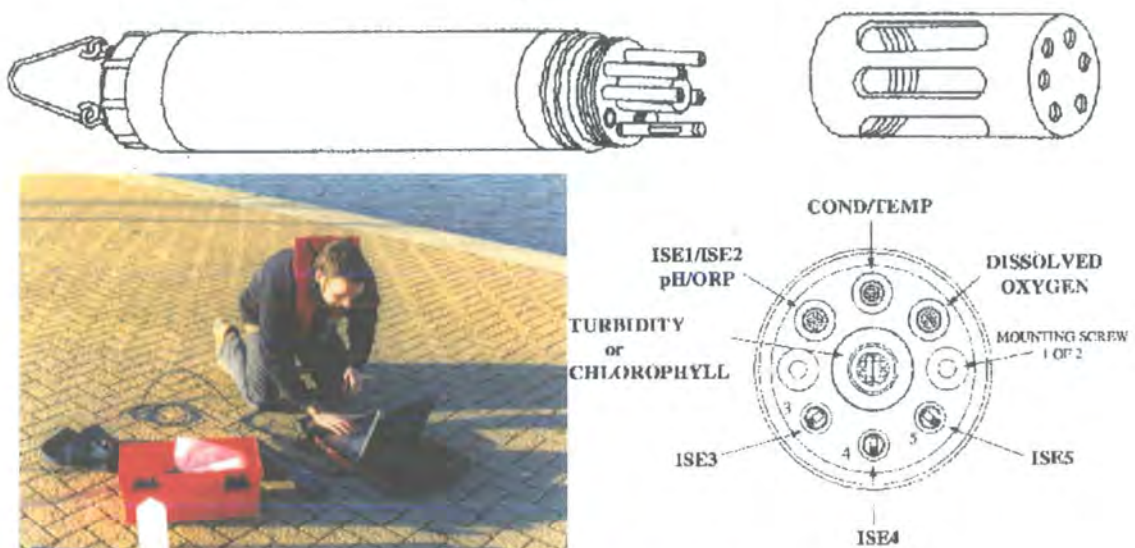
Figure 5-4 YSI Multi parameter sonde Model 6920 (YSI, 1999)

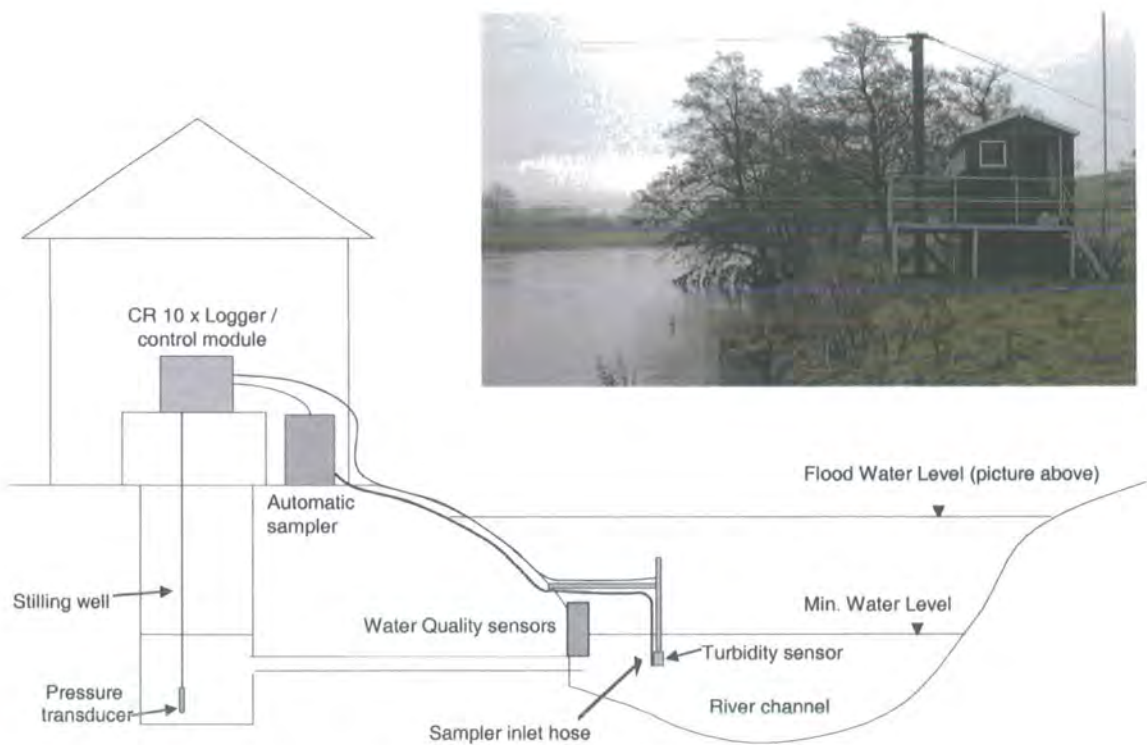
Figure 5-5 Low Moor gauging station, equipment set up

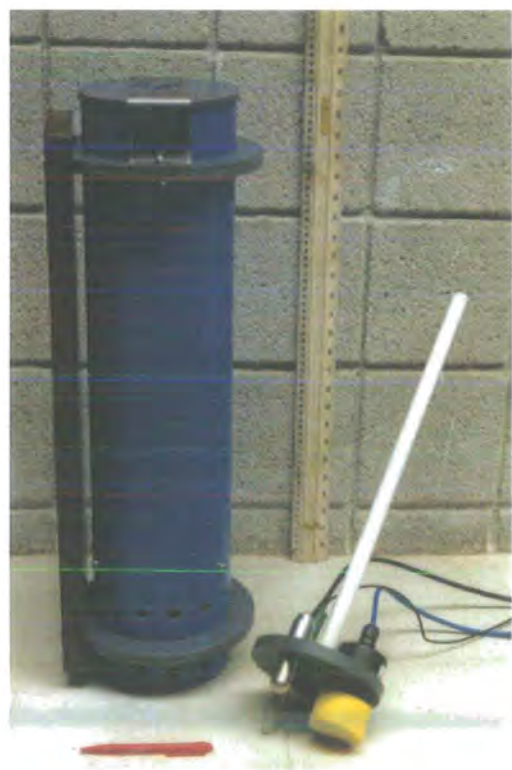
Figure 5-6 Sensor guard for Low Moor

Due to its susceptible position in the river, the water quality sensors required protection from the hydrodynamic forces and the debris associated with flood events. The novelty of this approach, using separate sensors in conjunction with a central data logger for continuous river water quality monitoring, required a new installation solution. A sensor guard was designed and built at Durham University to securely house the sensors as well as to allow quick maintenance access (Figure 5-6).

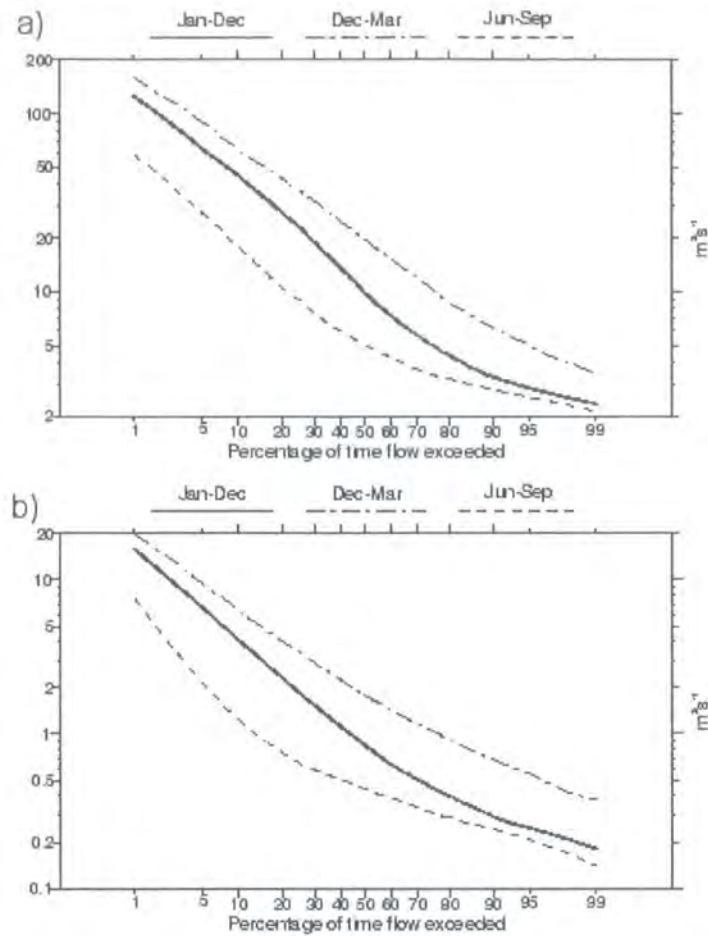
**Figure 5-7 Flow duration curve for daily gauged flows at a) Low Moor and b) Leven Bridge (National Flow Archive, 2003)**

River flow was continuously monitored by Durham University and the EA at Low Moor Gauging Station. The Durham University stage measurements are duplicates of the EA's recordings and the water level is converted into discharge using official EA rating curves. The 15 min. discharge readings were obtained from the EA to verify Durham University's measurements as well as to close record gaps resulting from station access restriction during the outbreak of Foot and Mouth Disease (February to December 2001). An additional contribution to the overall flow reaching the impoundment is given by the River Leven joining the Tees 12 km upstream of the barrage (Figure 5-1). The 15 min. records from the EA Gauging station at Leven Bridge (NZ 445 122) were also obtained and added to the Low Moor readings in order to account for the total fluvial discharge entering the impoundment. To provide consistency throughout this study it was decided to apply only the EA data sets during the analysis. The data was filtered to match the 30 min. recording interval of the YSI sonde. The flow duration curve for daily gauged flows at Low Moor (since 1969) and Leven Bridge (since 1959) is given in Figure 5-7.

As a result of the water storage, flow velocities decrease towards the barrage and residence time increases. The retention time of neutral water particle within the 12 km stretch for a mean daily flow of  $20.72 \text{ m}^3/\text{s}$  (50 percentile-Figure 5-7) is prolonged to 50 hrs (Figure 5-27). It is not possible at this stage to estimate the pre-barrage conditions.

A residence time of 200 hrs corresponds to a 75 percentile exceedance flow of 5.4 m<sup>3</sup>/s (Low Moor + Leven Bridge) (Figure 5-7), which was applied to calculate mean residuals experienced in relation to flow (Table 5-3).

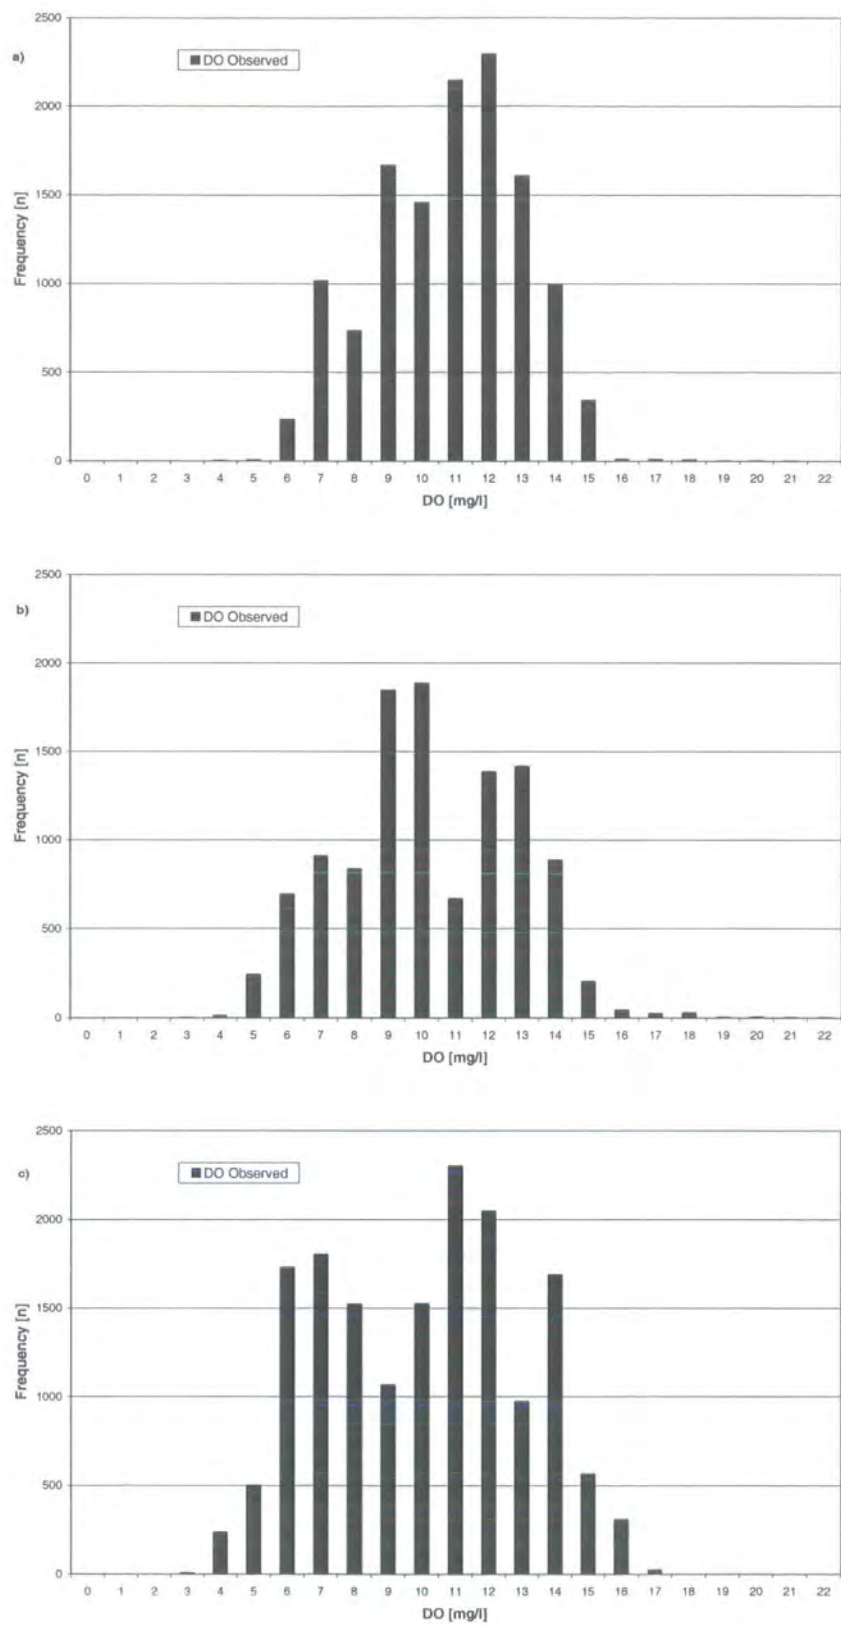
Figure 5-8 Histogram of DO concentrations measured in the Tees impoundment during the years a) 2000, b) 2001 and c) 2002

The 2002 DO histogram (Figure 5-8-c) shows an increased spread towards the lower intervals as already indicated by the mean summer values. However, levels below 5 mg/l only contribute a small portion to the DO conditions occurring in any one year with a maximum frequency of 1.4 % in 2002.

DO demonstrates consistent conditions throughout the wet months of January till March and October till December with mean levels >9 mg/l. Spring conditions are characterized by a large variability in DO levels with standard deviation values of 1.95 (June 2000) to 2.5 (May 2001) from mean levels between 8.86 and 11.81 mg/l DO. Summer levels in DO are naturally lower reaching low means <6 mg/l in August and September 2002 while mean values for 2000 and 2001 stayed >6 mg/l. Nevertheless, minimum values indicate the occurrence of conditions below 5 mg/l for all three years during the summer period. The frequency of DO levels (Figure 5-8) recorded during the monitoring period shows a near normal distribution which is centred around 10-11 mg/l DO.

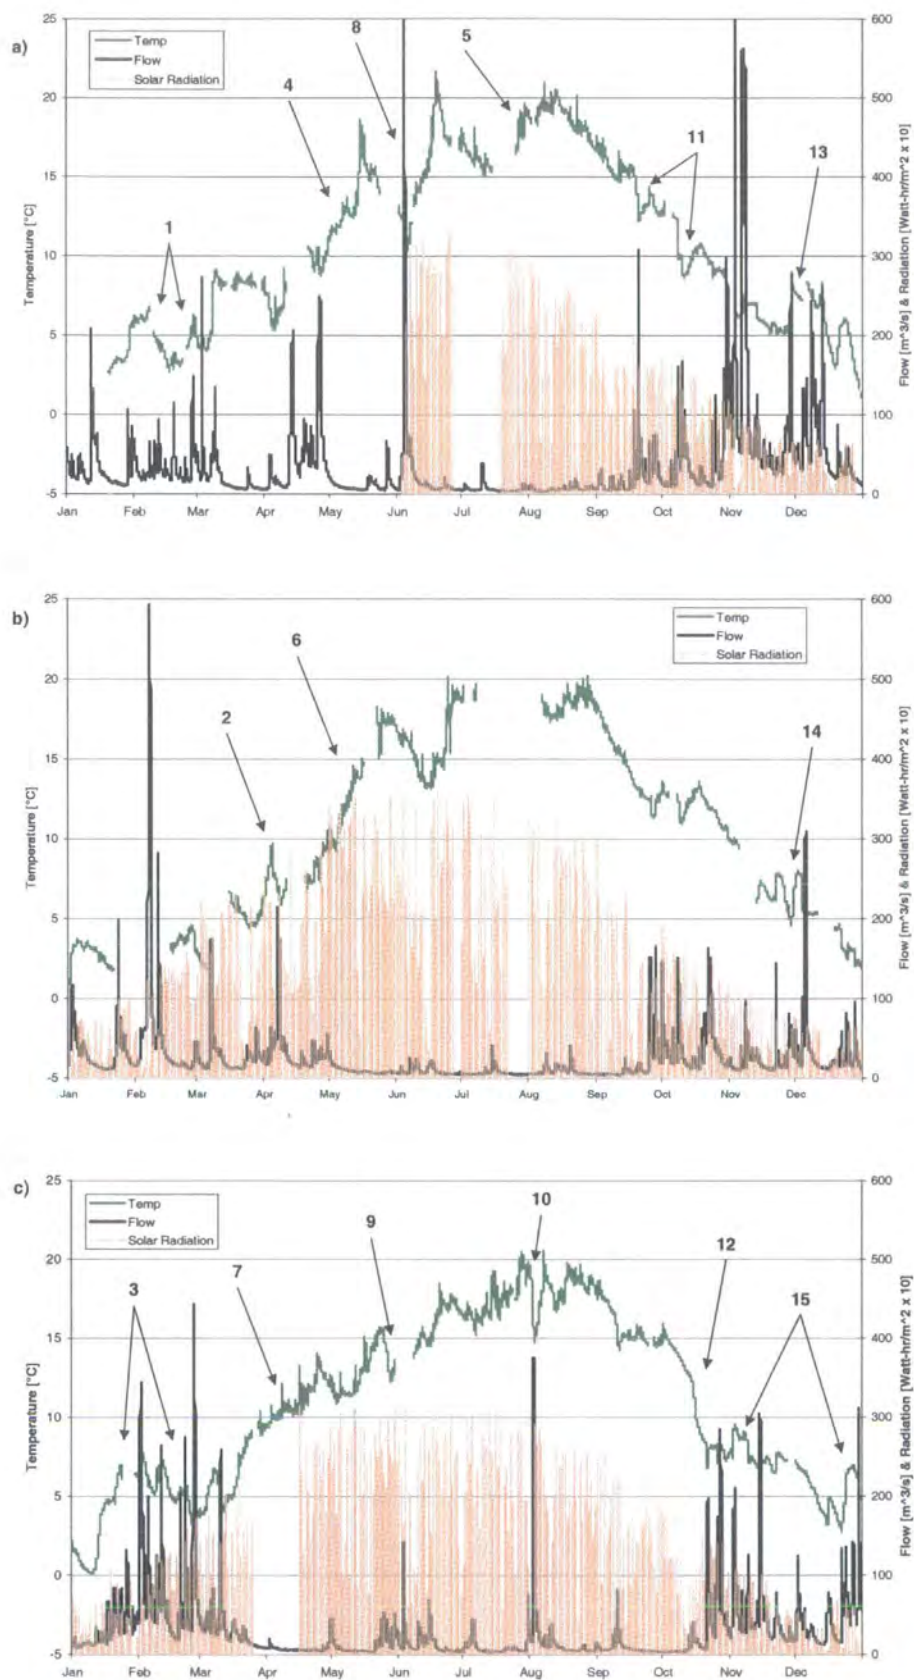
Figure 5-9 Annual time series of temperature within the Tees impoundment for the years a) 2000, b) 2001 and c) 2002, solar radiation gaps evolved from data gaps, not as a result of cloud cover, e.g. July 2000

Although slight temperature increases were introduced by flow events at the beginning of each year (Figure 5-9 Point 1-3), the main temperature rise correlated directly to the observed radiation records (Figure 5-9). Solar insolation warm-up was especially effective during periods of low flow (Figure 5-9 Point 4-7), while larger flow events lead to temperature drops during the summer months (Figure 5-9 Point 8-10). The higher frequency of larger events and declining radiation levels towards the end of each year resulted in a decline of water temperatures (Figure 5-9 Point 11-12). However, similar to the first months of the years, flow events at the end of the year also tend to warm up the impoundment at temperatures below 10°C (Figure 5-9 Point 13-15).

The temperature conditions within the impoundment show a strong seasonal variability following the annual cycle of temperature (Figure 5-9 a-c)).

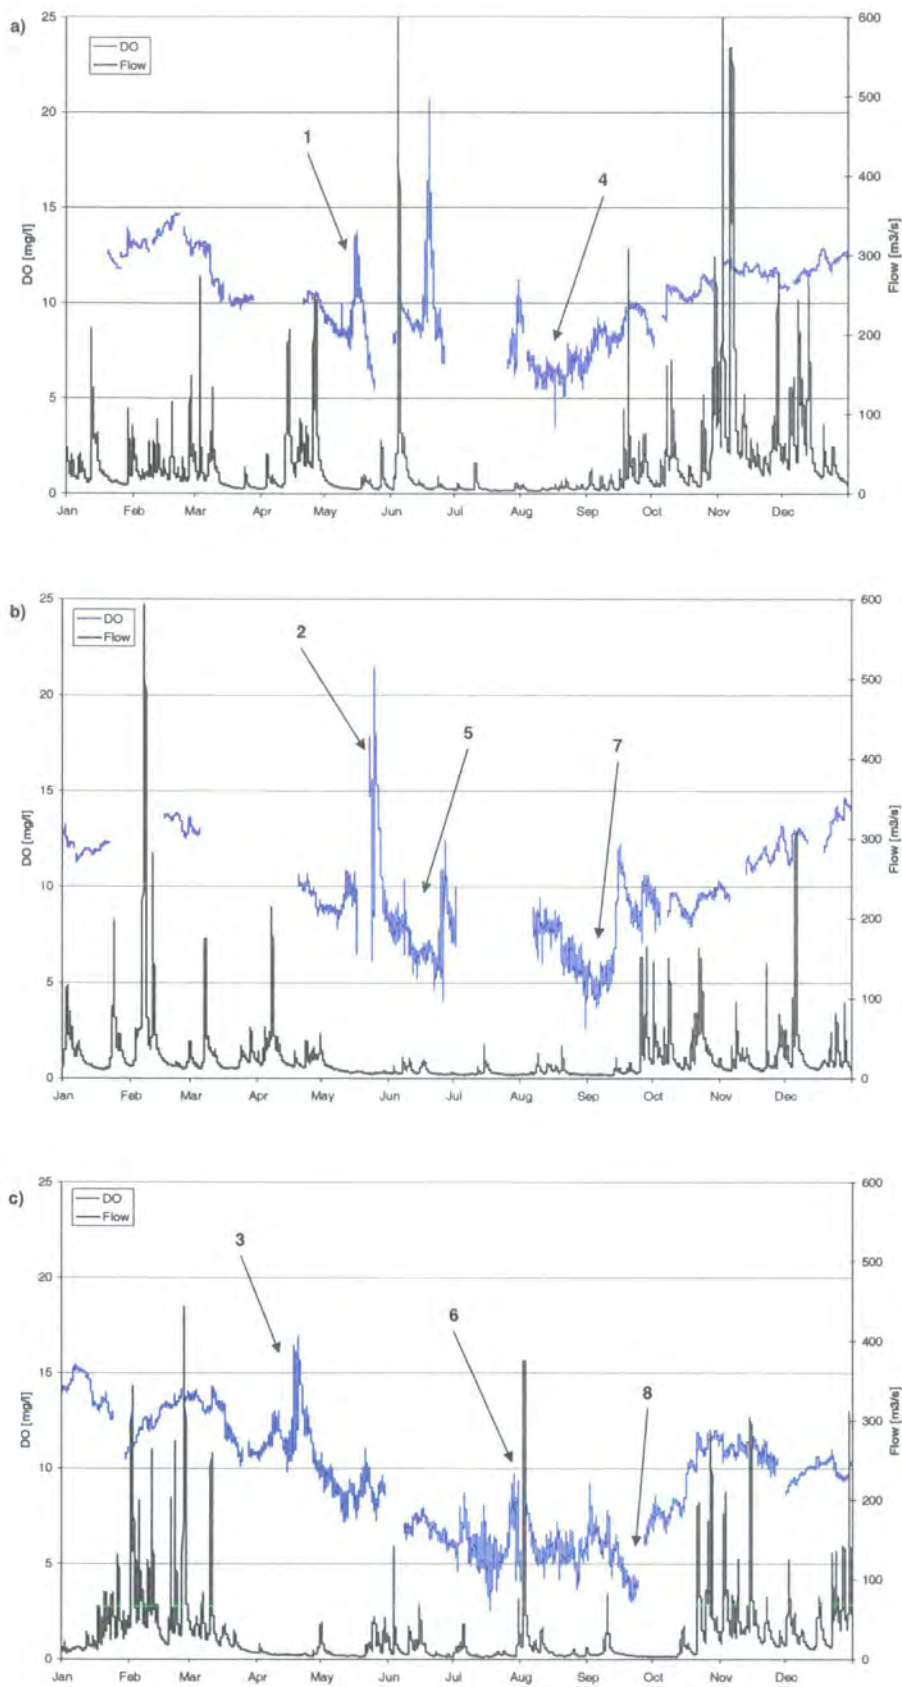
Figure 5-10 Annual time series of DO concentrations within the Tees impoundment for the years a) 2000, b) 2001 and c) 2002

As demonstrated in Table 5-2 consistently high concentrations of DO were found in the early months (January-March) of each year, which were dominated by high river discharges and low temperatures. Minor DO variations, occurring during these months, were mainly related to freshwater flow inputs (Figure 5-10 a-c). The months April and May showed the first major fluctuations in DO levels including super-saturation peaks up to 21.43 mg/l (227%) (Figure 5-10 Point 2), which were not associated with flow events (Figure 5-10 Point 1-3). The non-conservative behaviour (with flow) and the extreme levels reached indicate the arrival of algal 'blooms' as a result of increasing solar radiation (Figure 5-9). Following the blooms, low flow conditions and rising temperatures led to substantial decreases in DO concentrations (Figure 5-10 Point 4-5) that were only curtailed by flow events (Figure 5-10 Point 6). At the peak of summer temperatures and during long periods of low river discharges DO conditions fell below the 5 mg/l mark for several days (Figure 5-10 Point 7-8) until elevated discharges provided cooling and mixing within the water body resulting in enhanced DO levels. A general stabilisation of DO conditions occurs towards the end of each summer season as a result of the higher frequency of larger flow events. In 2000 and 2001 stabilisation occurred at the end of September while conditions remained dry and slightly reduced up until mid October in 2002.

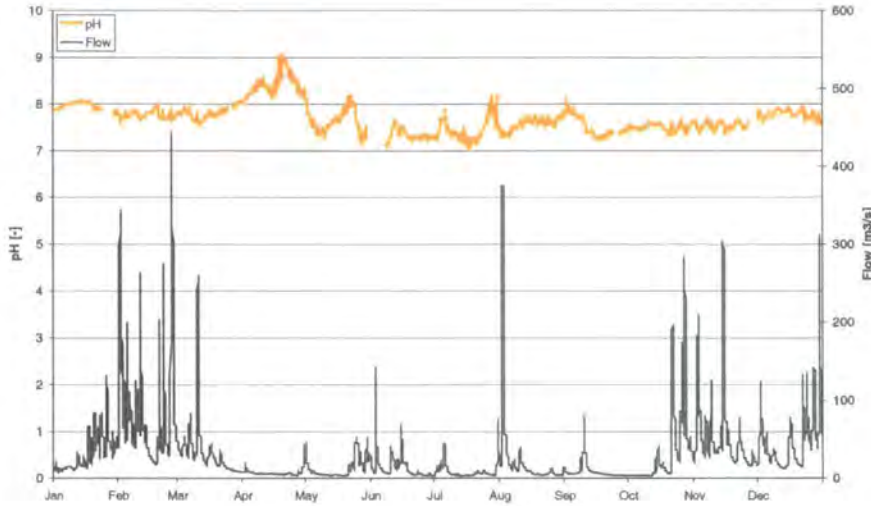
**Figure 5-11 Annual time series of pH within the Tees impoundment for the year 2002**

Although pH values seemed to be slightly lower in the summer, the early season is also dominated by pH peaks coinciding with the arrival of algae as observed in section 5.3.2.2. Elevated freshwater flows during the winter result in balanced pH conditions between 7.5 and 8.0 with no major fluctuations recorded throughout the observed years.

The time series for pH indicates small annual variation during the observed years. Therefore, only one annual example is provided (Figure 5-11). The water body shows a well buffered pH range between 7 and 9.

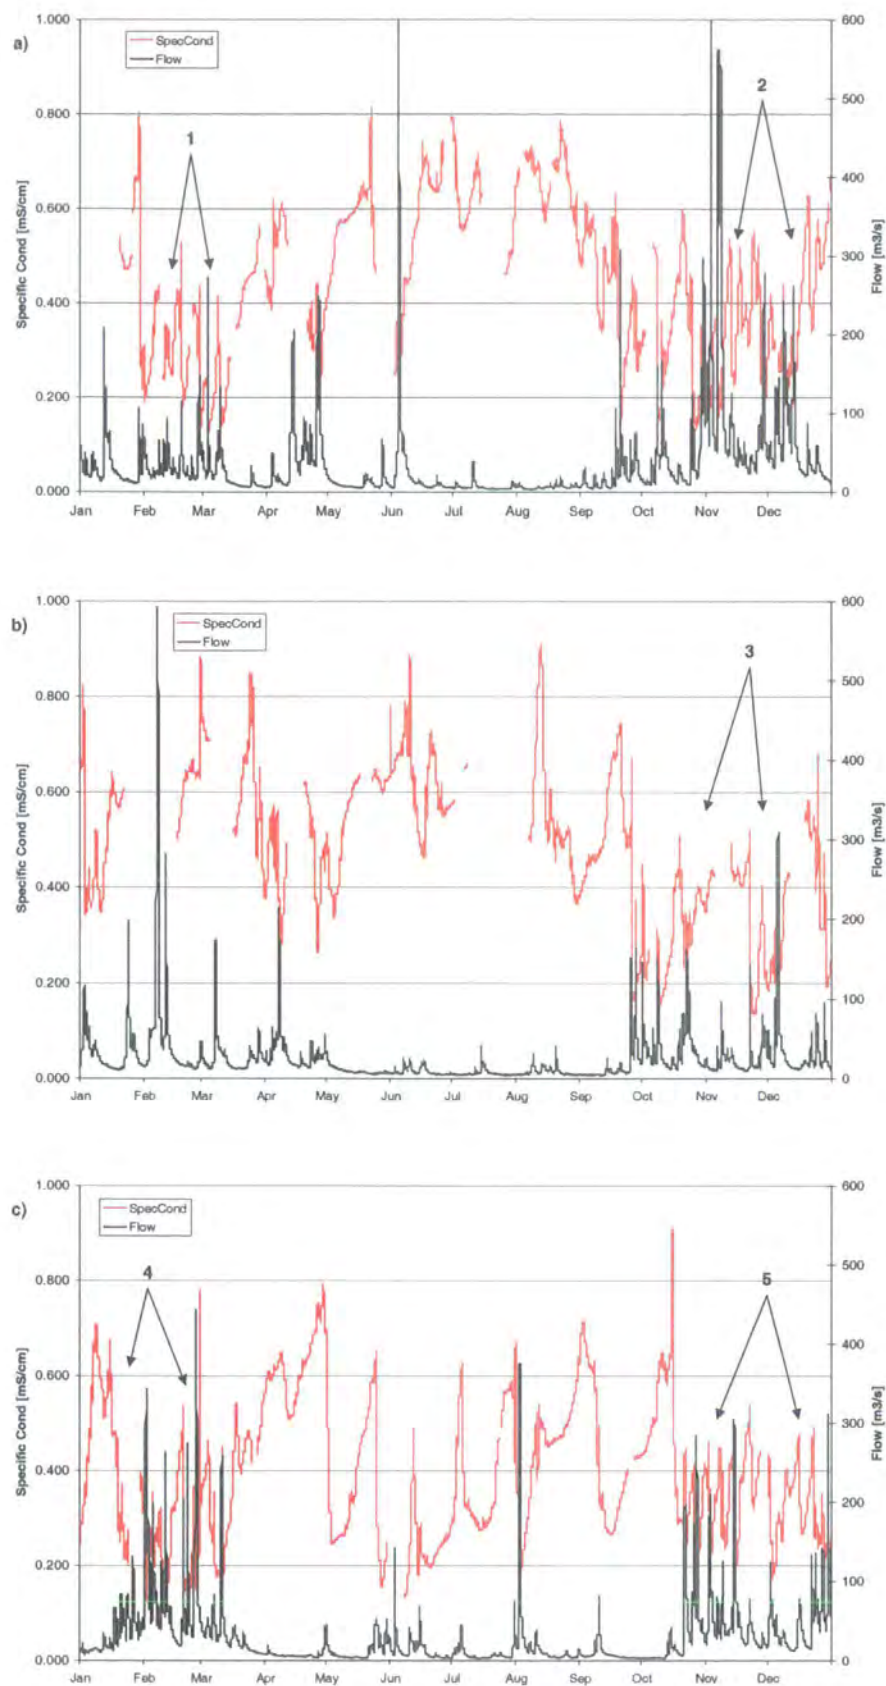
Figure 5-12 Annual time series of Specific Conductance within the Tees impoundment for the years  
a) 2000, b) 2001 and c) 2002

The time series for conductivity levels in the impoundment exhibits a strong dilution effect with increasing flow. Seasonal variation is minimal and corresponds to flow conditions resulting in longer periods of higher conductance levels between 0.6 – 0.8 mS/cm throughout the summer months of 2000 (Figure 5-12 a)). The large dilution effect of even small events led to lower levels and to a high variation during the summer in 2002 (Figure 5-12 c)). A regular distribution of peaks, especially during the low flow summer months of all years, is noticeable. However, the peaks were always curtailed by flow events and are not directly correlated to the tidal frame. High frequencies of flow events during the winter months result in values between 0.2 – 0.4 mS/cm with peaks occurring on the recession of flows (Figure 5-12 Point 1-5). This is explained in detail in the following section.

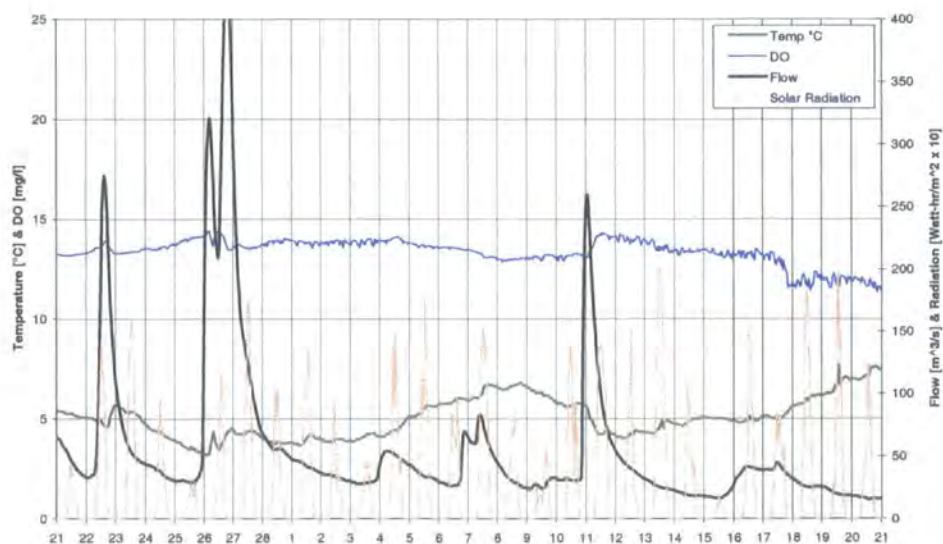
Figure 5-13 Early spring season time series of the Tees impoundment 21/02-21/03/02

It is indicated that the temperature curve generally follows the progression of radiation levels with increases occurring after longer periods of constant radiation on the 07/03 and 20/03. However, the three events above  $250 \text{ m}^3/\text{s}$  on the 22/02, 26/02 and 11/03 resulted in a temperature adjustment below  $5^\circ\text{C}$ . A direct cooling effect is noticeable for the event on the 11/03, which was preceded by a cloudy day. The larger event on the 27/02 with a peak flow of  $433 \text{ m}^3/\text{s}$  coincided with higher radiation levels and buffered the impact to temperatures below  $5^\circ\text{C}$  until the next radiation wave on the 04/03 set in to warm up the impoundment. DO levels were constantly high at  $11\text{--}14 \text{ mg/l}$  due to the low temperatures and high frequency of incoming freshwater pulses. DO variations during events and warm up seemed directly related to the temperature changes occurring.

As seen in section 5.3.2.1, early spring season provides rapid warm up within the impoundment but is also accompanied by the occurrence of flow events. A closer look at a monthly time series (Figure 5-13) covering this season reveals the impact that different sized events can have on the process of raising water temperatures and oxygen levels of the impoundment.
